DARNLEY ARCHAEOLOGICAL SERVICES

THE ORB, 243 RAMSGATE ROAD, MARGATE, KENT CT9 4EU

Level 3 Building Recording Survey

Report Number DAS 008/20/ORB20-BS

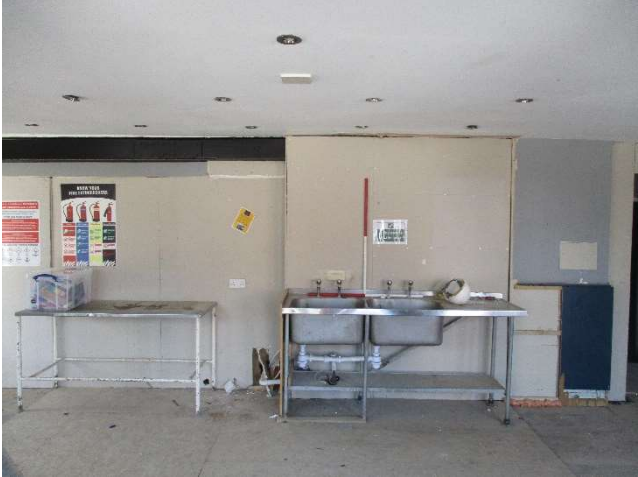
<p>1</p> <p>Room 1 – steel RSJ visible and a recently added double sink and drainer unit is attached to the stud wall.</p>

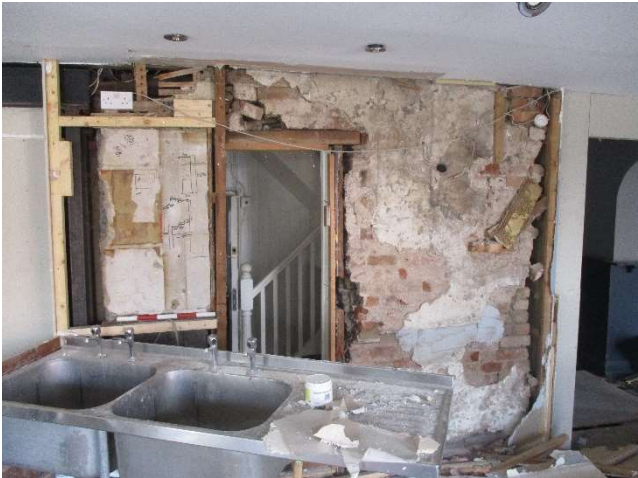
<p>2</p> <p>Room 1 – stripping back plasterboard revealed an earlier doorway surrounded by brickwork to the west overlain with horsehair plaster.</p>

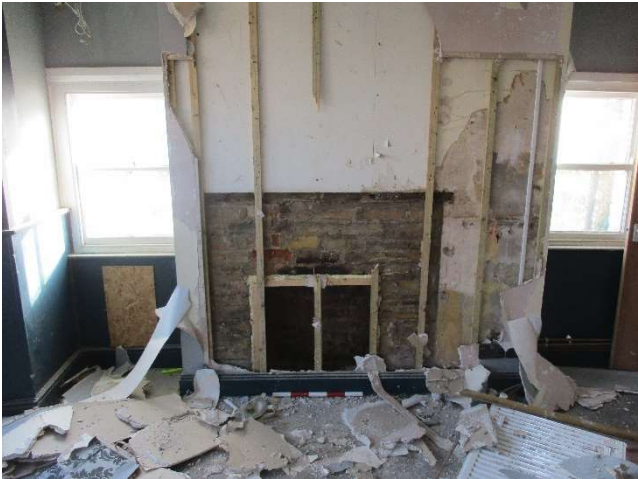
<p>8</p> <p>Room 1 – removal of the plasterboard shows the original flue area, but the cast iron fireplace has been removed.</p>
	<p>9</p> <p>Room 1 – an open hearth remains after</p>

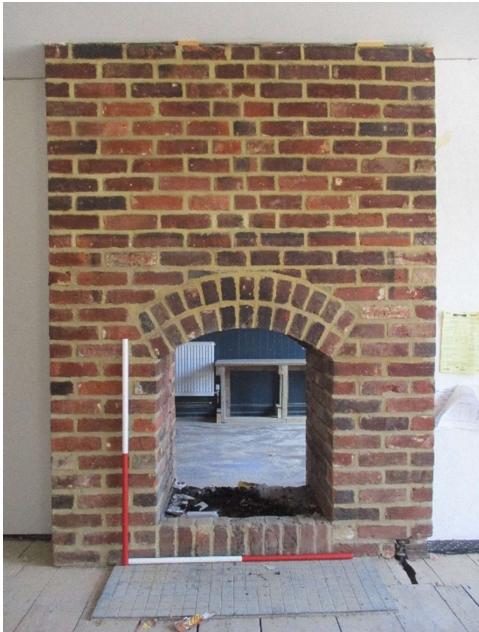
<p>the demolition on the original gable wall. However, it appears this fireplace has been adapted (double aspect), and new brickwork applied.</p>
---	---

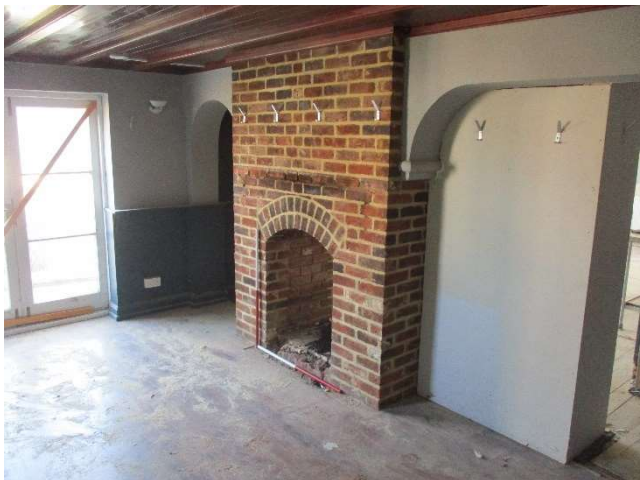
<p>11</p> <p>Room 2 – the wall was incorporating the fireplace which has moulded plaster arches either side of it which are mid-late 20th-century additions.</p>

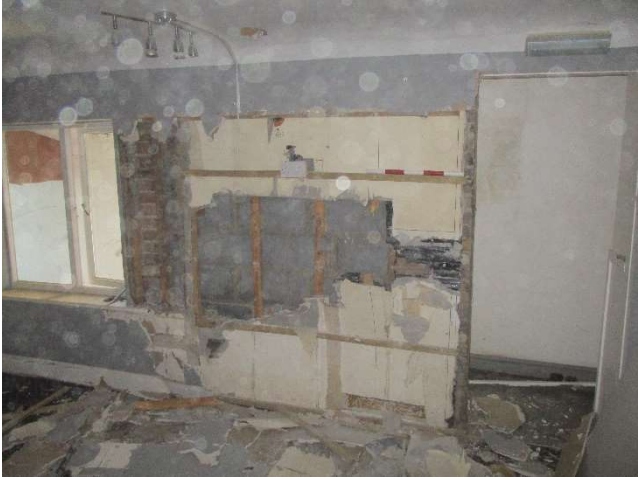
<p>20</p> <p>Room 8 – Removing the plasterboard from this wall revealed the original exterior wall and a concealed window.</p>

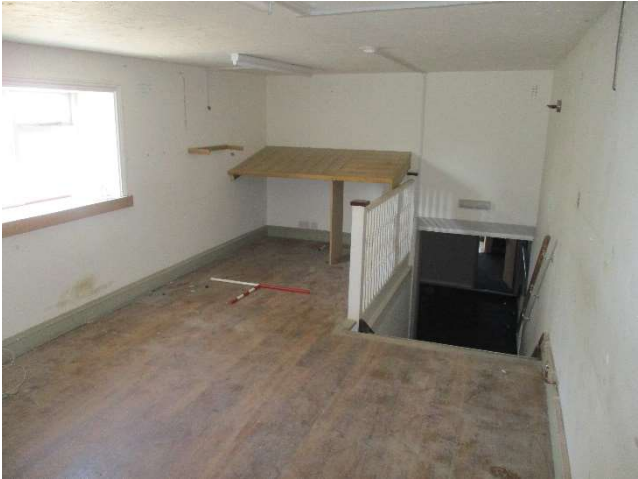
<p>21</p> <p>Room 9 – a staircase leading from Room 9 down into Room 8. The floor is a modern addition, and the extension building (Phase C) was likely one large, attached outbuilding rather than the current two-floor structure.</p>

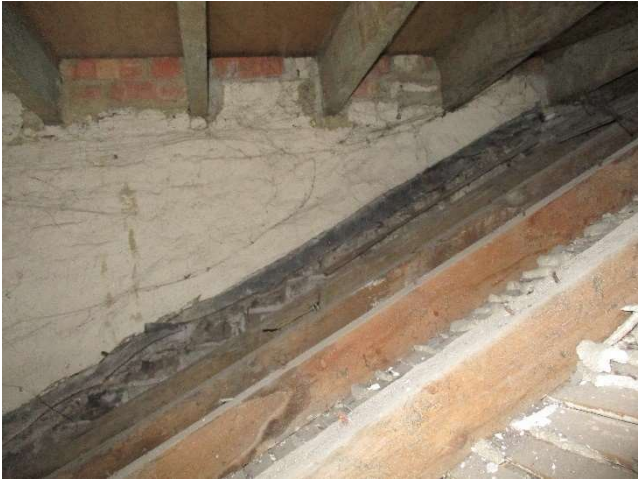
<p>27</p> <p>Viewed from Room 10 (kitchen), the rafters (lower) of the lean-to pitched roof structure.</p>

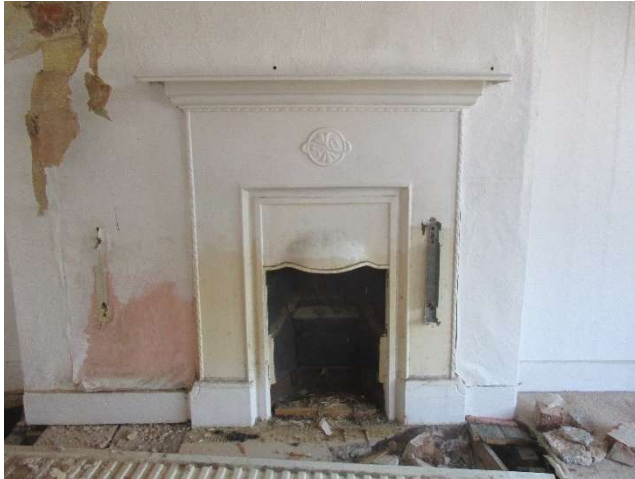
31

Room 11 - The chimney breast contains a fireplace currently obscured by a modern radiator which, once removed, showed a cast iron decorative fire grate

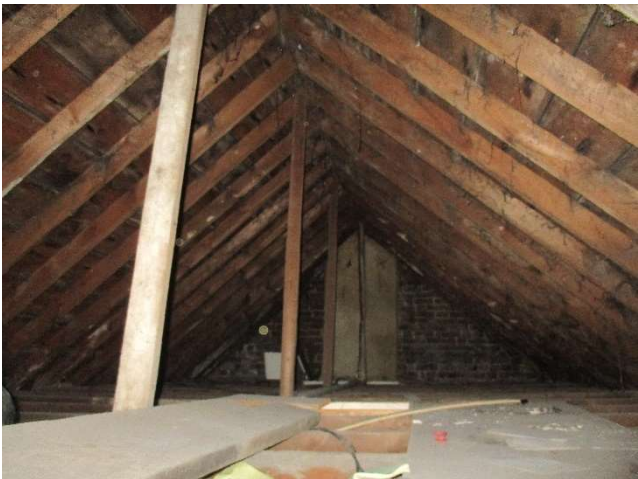
4.2.7. The central upper corridor is connecting the landing with the lobby of Rooms 11 and 12, Room 13 and Room 14. Stud walls to the south with doorway to bathroom and brick wall to the north with wall-mounted modern light. The walls are papered and the floor carpeted with simple wooden skirting boards surrounding the walls. The ceiling is plasterboard with loft access to the roof void of the original building: the roof void presenting rafters which appear original and a mixture of original and replacement beams. The flue stack to the southeast of the roof space is a later addition (38).

<p>38</p> <p>The central upper corridor is connecting the landing with the lobby of Rooms 11, 12, 13 & 14: the roof void presenting rafters which appear original and a mixture of original and replacement beams. The flue stack to the southeast has been rendered with mortar.</p>

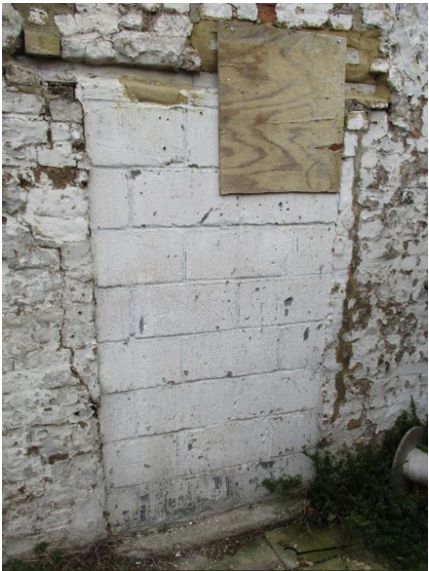
<p>65</p> <p>Bricked up doorway in the rear wall of Phase C looking northeast.</p>

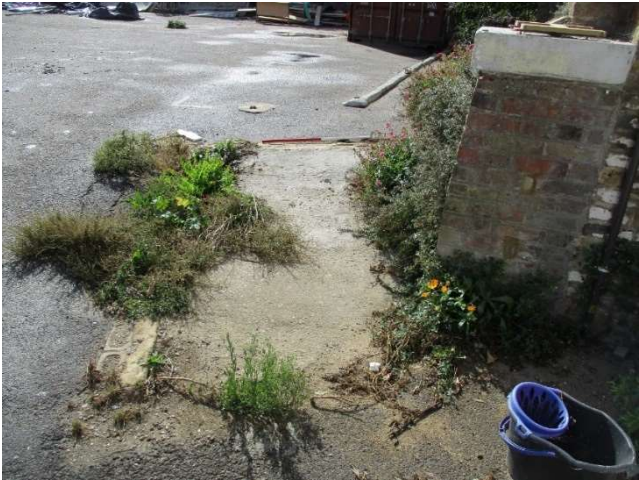
<p>76</p> <p>Remnants of possible earlier extension to the west of Phase A looking south.</p>
