DARNLEY ARCHAEOLOGICAL SERVICES

THE ORB, 243 RAMSGATE ROAD, MARGATE, KENT CT9 4EU

Level 3 Building Recording Survey

Report Number DAS 008/20/ORB20-BS

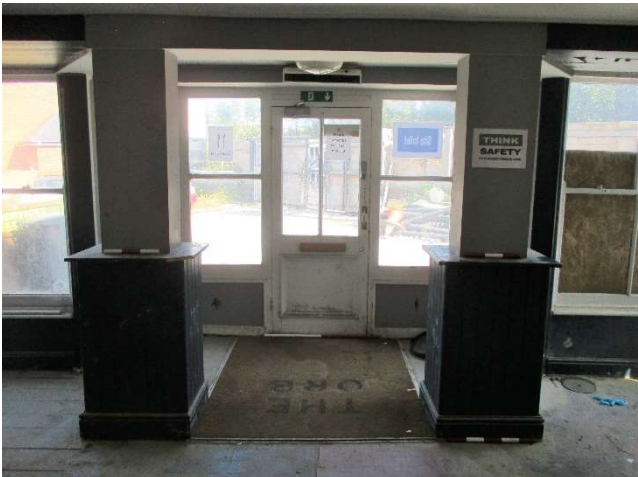
<p>3</p> <p>Room 1 – accessed from the exterior via the north-east front door in the entrance porch extension.</p>

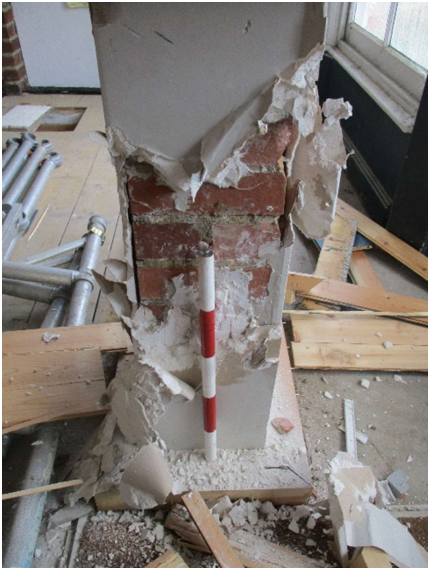
<p>5</p> <p>Room 1 – Further investigation suggests the pillars are relatively modern additions due to their modern brickwork construction.</p>

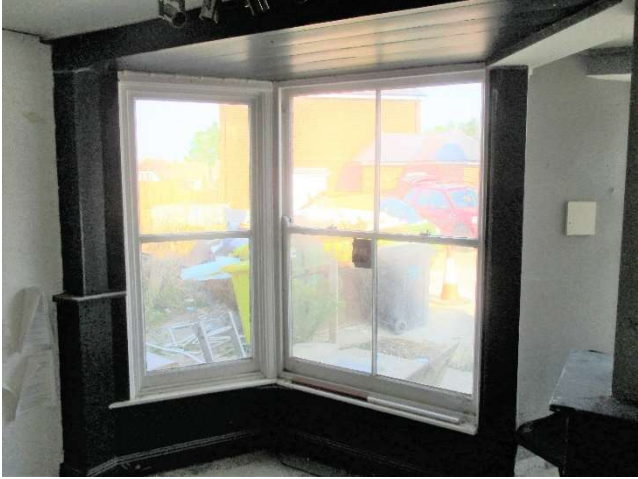
<p>6</p> <p>Room 1 – bay sash window on the west side of the door, rendered with wood panelling to the roof of the alcove.</p>
Image	Number & Description

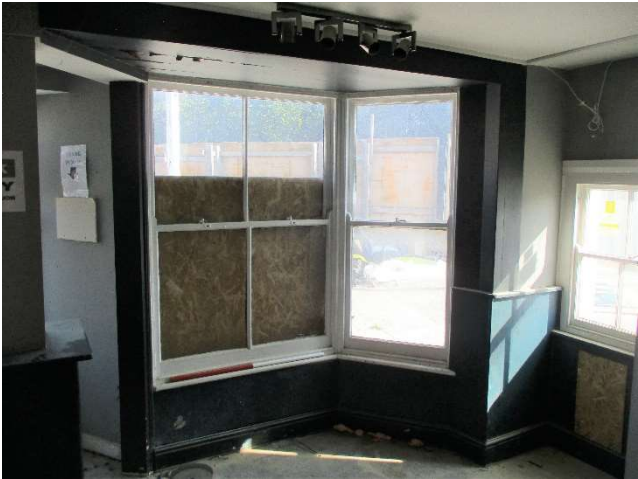
<p>7</p> <p>Room 1 – a bay sash window on the east side of the door, rendered with wood panelling to the roof of the alcove.</p>

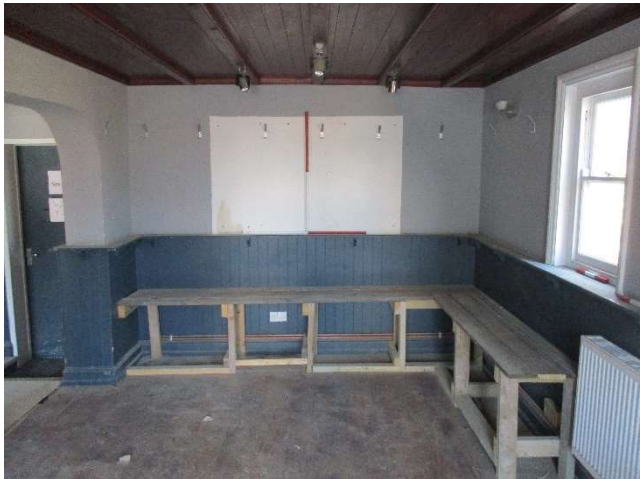
<p>10</p> <p>Room 2 – walls are plastered and painted with wood panels covering the lower extent of these walls. The ceiling is rendered with timber panelling with recessed spotlights. The flooring is a modern wood effect laminate.</p>

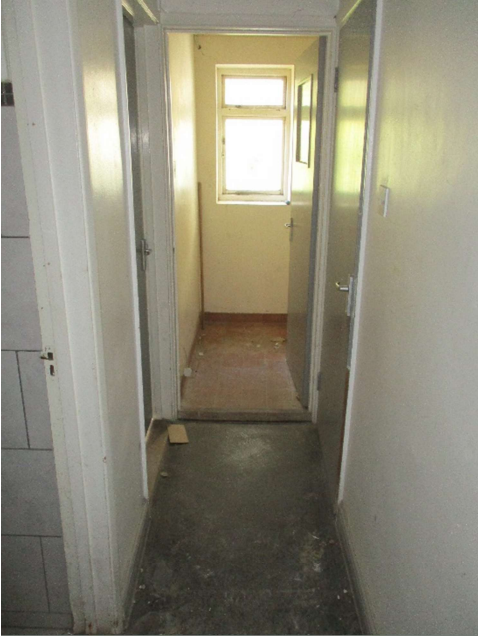
<p>12</p> <p>Room 3 – a small storage room with an open latch window on the brick-built west wall and a ceramic tiled floor.</p>
---	---

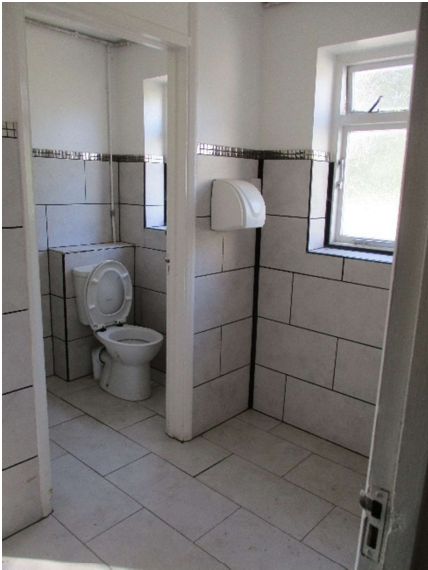
<p>13</p> <p>Room 4 – former ladies toilet consisting of a communal area and two cubicles with closed cistern porcelain toilets and wood-panelled doors.</p>
	<p>14</p> <p>Room 5 – former gents toilets entered from the southwest wall of the corridor via a modern wood-panelled door.</p>

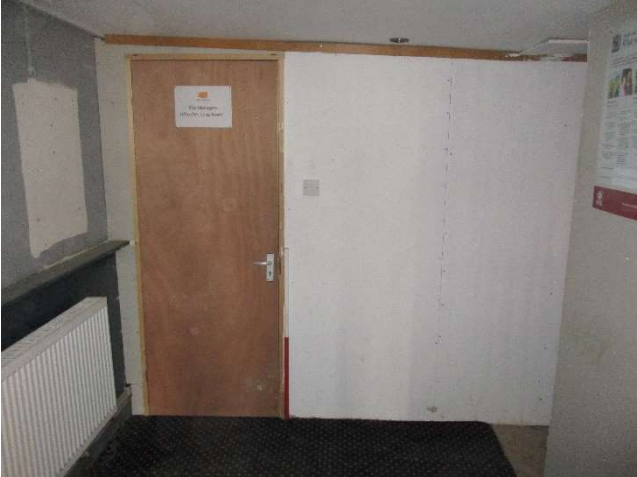
<p>15</p> <p>Room 6 - created by modern plasterboard partitions across the middle of the bar area and a division erected to separate it from the kitchen area, Room 7 (right). The original external wall of the L-shaped building seen on the left.</p>

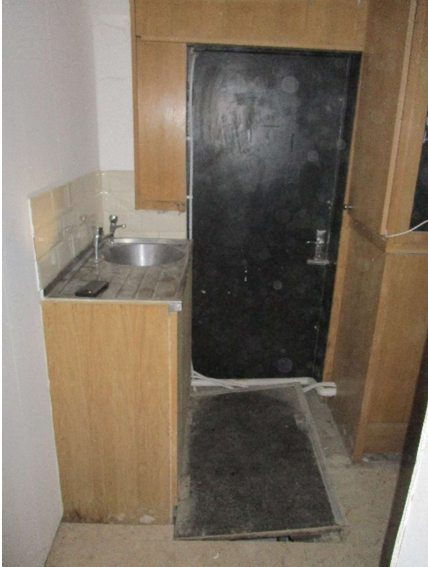
<p>16</p> <p>Room 7 – looking west at doorway giving access to the toilet area. Cellar hatch visible in the foreground.</p>

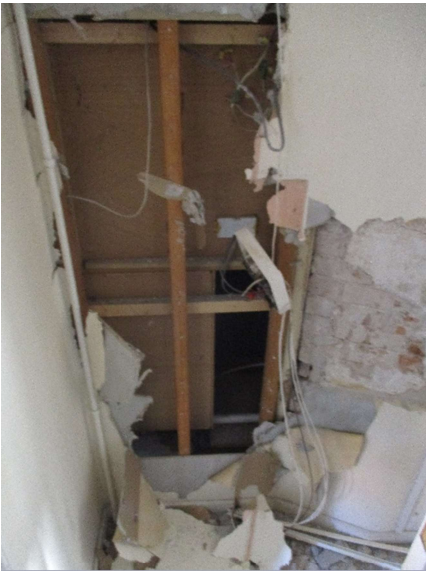
<p>17</p> <p>Room 7 – further investigation work on the west side of the northeast wall revealed an earlier doorway, providing access from Room 7 (or an earlier aspect of the bar) to the internal staircase (foreground) leading to the first-floor accommodation.</p>

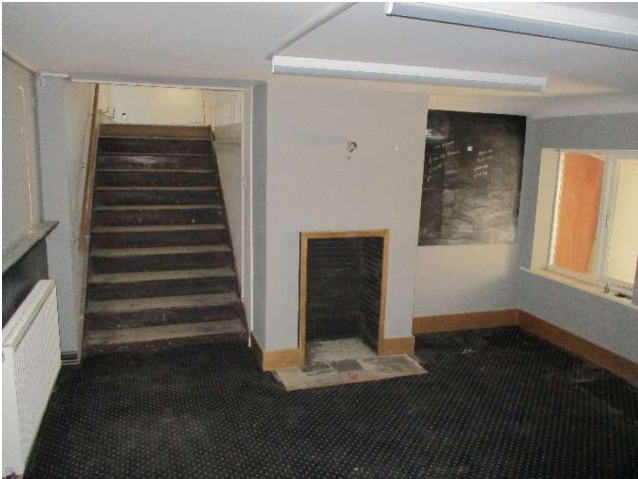
<p>18</p> <p>Room 8 – looking southwest into Room 8; staircase to Room 9 on left and fireplace in the centre.</p>
Image	Number & Description

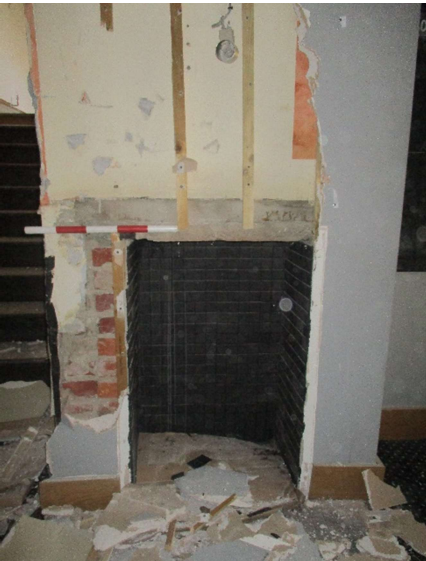
<p>19</p> <p>Room 8 – fireplace with original fire grate removed.</p>

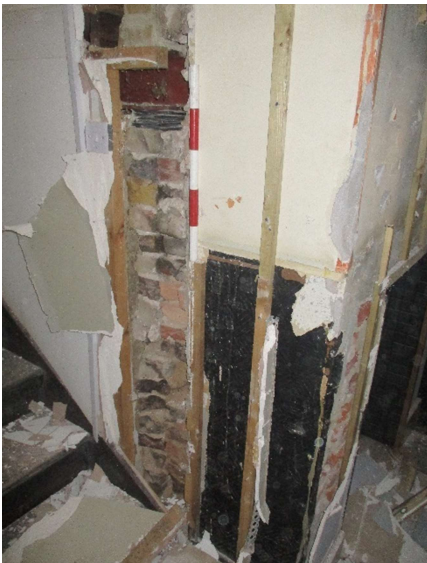
<p>22</p> <p>Room 9 – bonding between the original exterior wall in Room 8 and the bonded extension building seen in Room 9.</p>

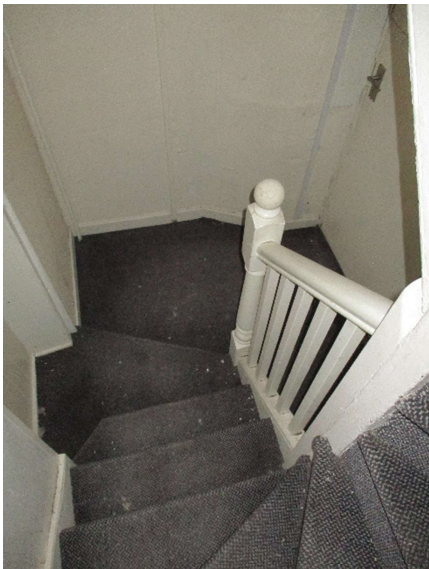
<p>24</p> <p>Staircase – The internal staircase allows access to the first floor the build which covers Phase A and has the addition of phase F. Image taken before demolition revealing doorways feature in 2 & 17.</p>

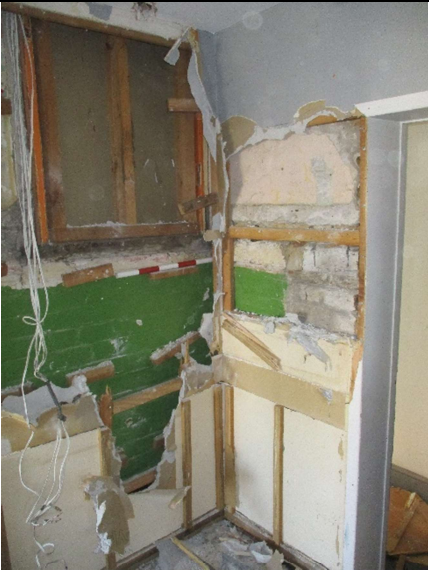
Image	Number & Description
	<p>25</p> <p>A further investigation between Rooms 1 & 2 confirmed the presence of a lower door frame, which continues up into the stairwell cupboard. It is thought this doorway provided external access (via lean-to pitched roof structure) to the first-floor accommodation.</p>

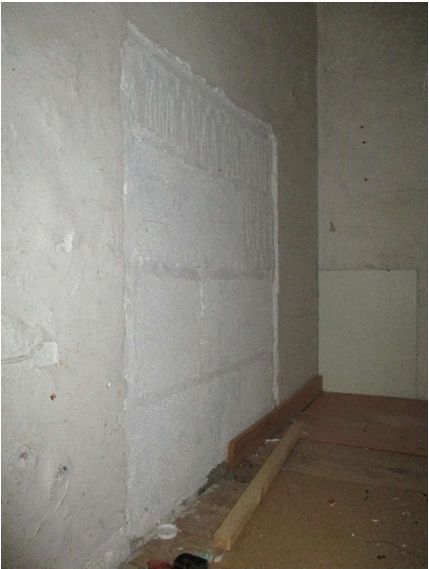
<p>26</p> <p>Viewed from the stairwell cupboard, further up the southwest wall (above the concealed doorway), a blocked-up window, Thought to have provided additional light into the lean-to pitched roof structure.</p>

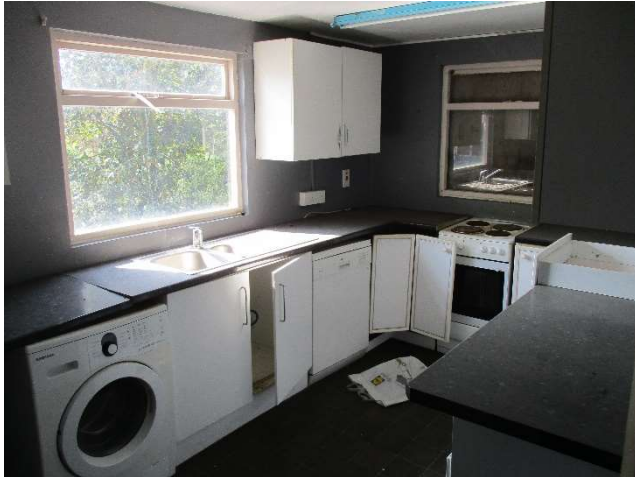
28

Room 10 - kitchen
looking southwest.

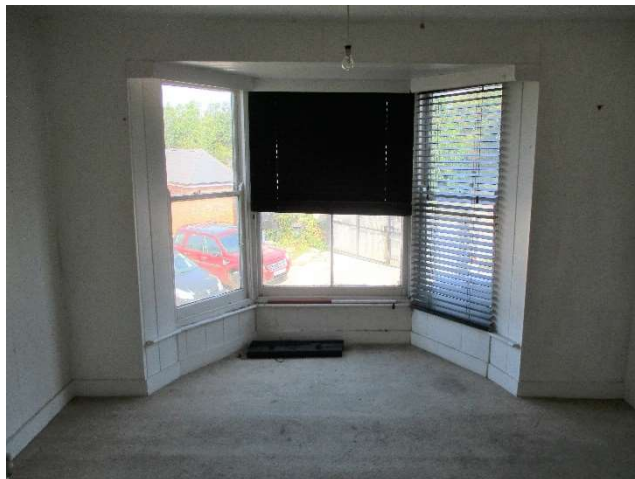
29

Room 11 – west
bedroom looking
northeast through
recess bay window.

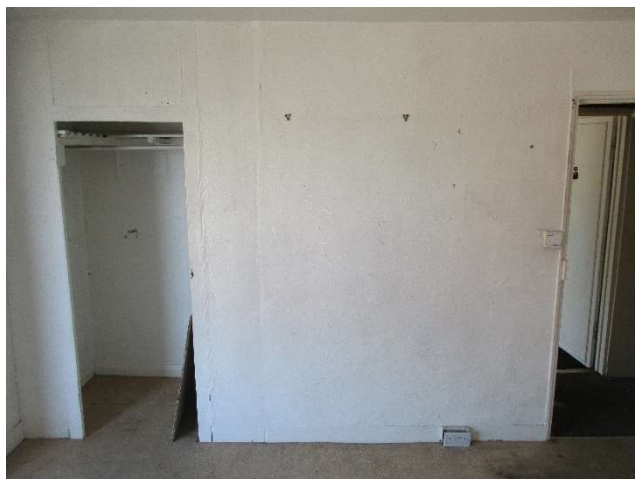
30

Room 11 - The east
lath plaster wall gives
way to a small
cupboard at the
northwest end of the
wall that may have
served as a wardrobe
and has a wooden
slatted shelf on the
north side

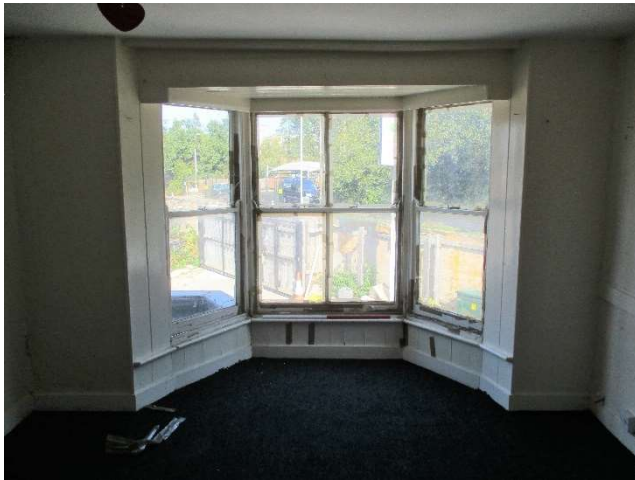
32

Room 12 – east bedroom looking northeast through recess bay window

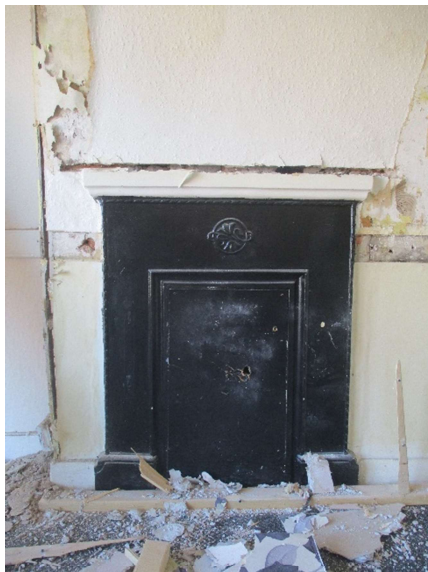
33

Room 12 - The chimney breast contains a fireplace obscured by plasterboard which, once removed, showed a cast iron decorative fire grate.

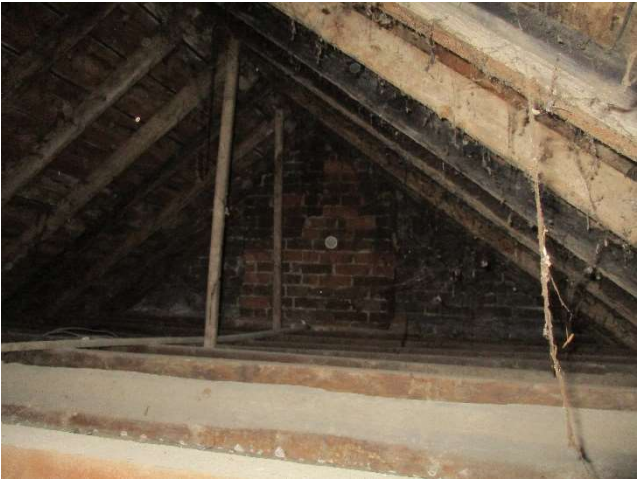
4.2.5. A loft hatch in the lobby ceiling between Rooms 11 and 12 allows access to the Phase A pitched roof space (34). Visible in the roof space are brick chimney flues at end the east and west ends of the roof void which are later additions. The walls at the northwest and southeast ends do appear contemporary. The principal rafters appear to be original as do the struts although the beams appear to have been replaced. The principal rafters are partially enclosed by wooden planks (35 & 36).

<p>35</p> <p>Looking northwest through the attic, toward chimney flue stack.</p>

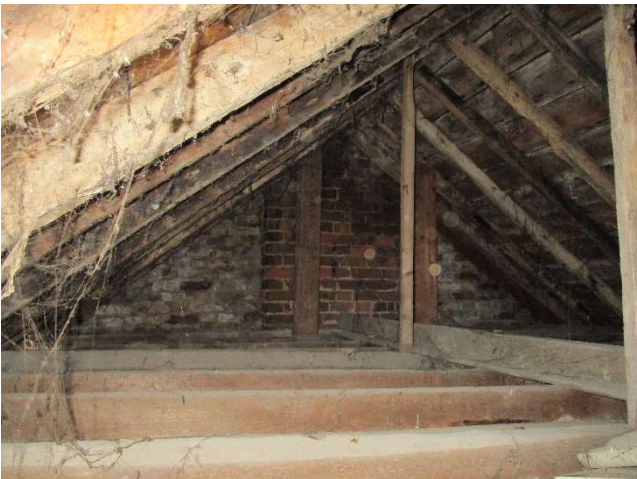
<p>36</p> <p>Looking northeast through the attic, toward chimney flue stack.</p>

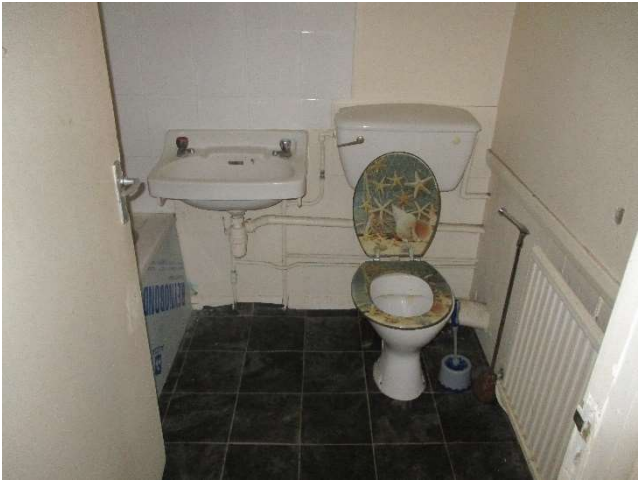
4.2.6. Room 13, housed within the original building, most recently used as a bathroom, is accessed via a modern wood-panelled door. Floor to ceiling tiled splashback on the full east and part of the north and west walls. Modern ceramic bathroom suite consisting of bath, wall-mounted handwash basin with stainless steel taps and ceramic toilet pan and cistern suspended above. Modern wall-mounted radiator to the west wall and tile-effect vinyl flooring. Plaster ceiling with single bulb central light fitting. There is no natural light in this room, and nothing historically significant (37).

<p>37</p> <p>Room 13 – Modern partition bathroom with nothing historically significant.</p>

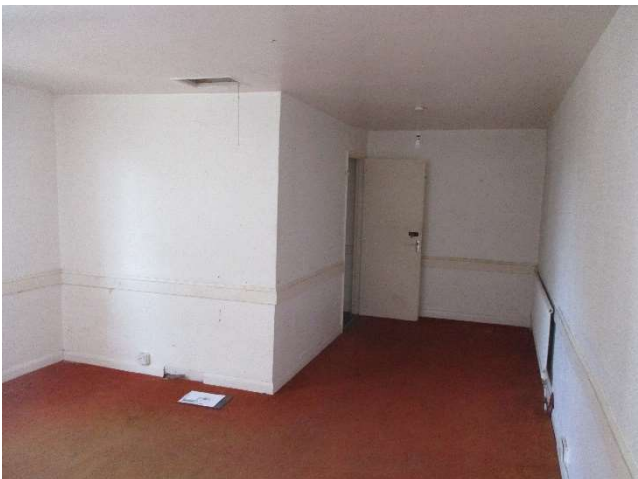
<p>39</p> <p>Room 14 - part of the original L-shaped building, likely used as a living room. Adaptation housing bathroom can be seen on the left.</p>

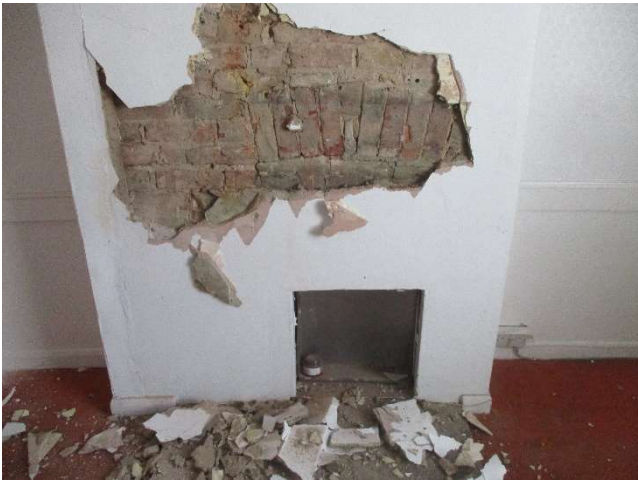
<p>41</p> <p>Room 15 - a brick chimney breast in the south wall with an open, metal-lined fireplace which may have housed a small modern gas fire, with a flagstone hearth. Only the surrounding brickwork from the original fireplace survives.</p>
 	<p>42</p> <p>Entrance hatch in front of phase A; consists of wooden folding double doors of 19th-century date secured by iron braces, hinges and clasps. Hatch gives access to a modern breeze block-lined loading bay for the cellar contents and accessing Room 15</p>

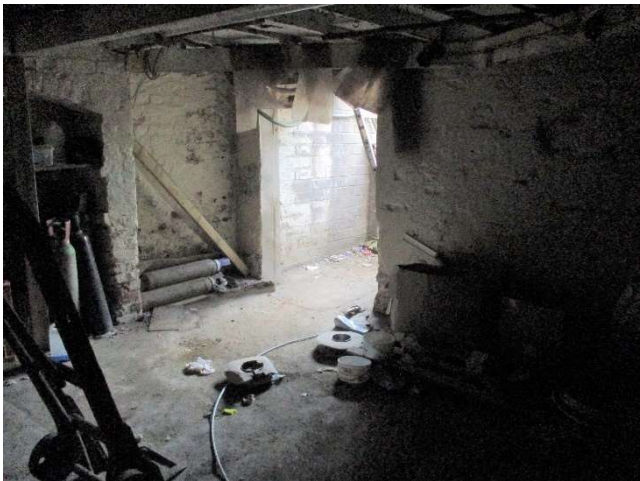
<p>43</p> <p>Room 15 – brick-built whitewashed walls with a concrete hard-standing floor and a wooden ceiling which is probably original.</p>

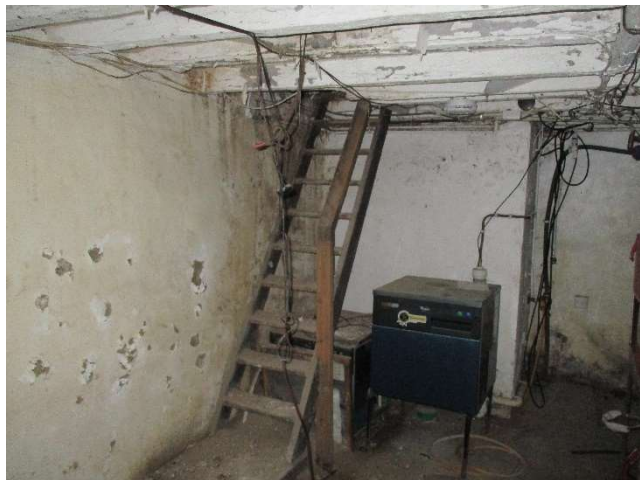
<p>44</p> <p>Room 16 - brick-built whitewashed walls with a concrete hard-standing floor and a wooden ceiling which is probably original. Room 16 has a timber staircase of 20th-century date allowing access to Room 7.</p>

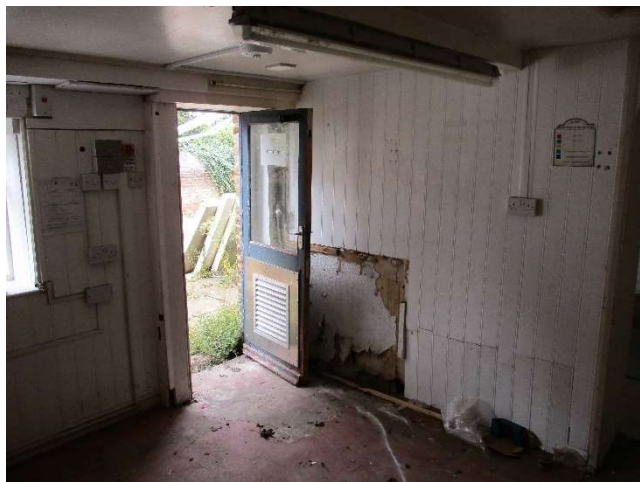
<p>45</p> <p>Room 17 - access via the part-glazed timber panelled door with a metal plate and grill in the bottom half.</p>

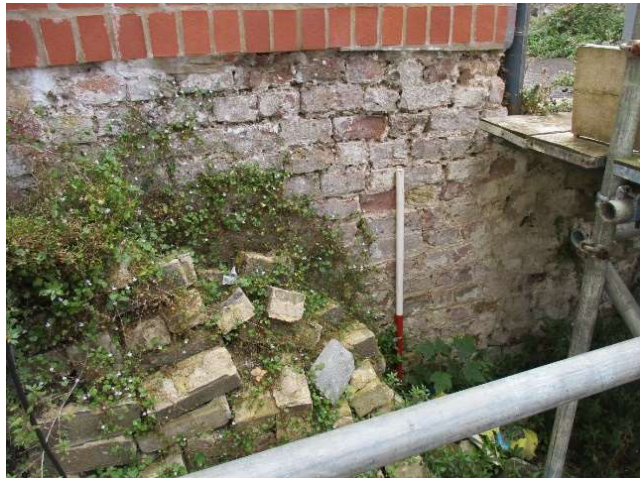
<p>68</p> <p>Retaining wall to the rear of Phase C looking south.</p>

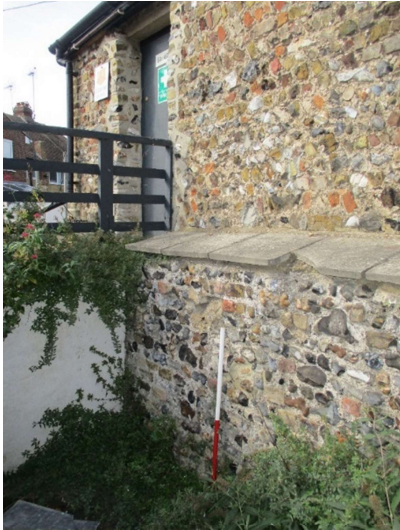
<p>71</p> <p>Chapel Hill retaining wall and side elevation of Phase C looking southwest.</p>

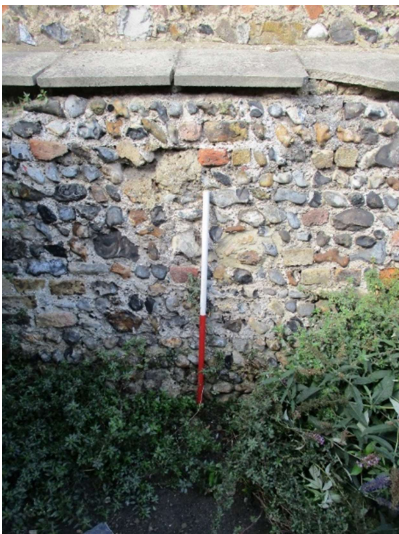
<p>72</p> <p>Chapel Hill retaining wall looking northwest with shallower-angled capstones.</p>
